DESCRIPTION

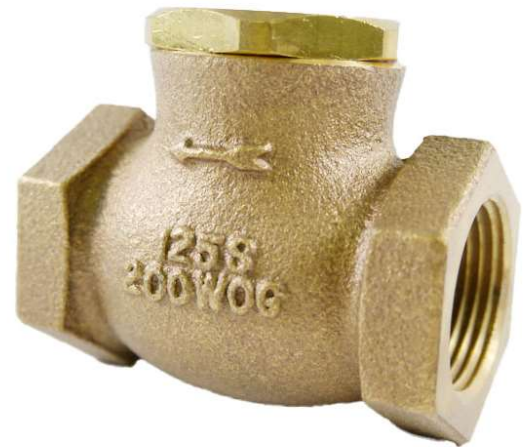
The bronze swing check valve features a full floating clapper assembly that provides for a positive seal each time the valve is cycled. This feature improves the ability of the swing check valve to “clear” any debris that may be present in the water supply. The seat material is NBR which provides for a positive seal even under light residual pressures.

For horizontal installation only. The female x female swing check valve should be installed in accordance with commonly used installation practices for the fire sprinkler industry. Proper sealing of the threads can be accomplished by applying a liberal amount of PTFE based thread sealant. Never use tape and paste together. This will cause excessive stress on the threaded connection leading to failure of the valve. Do not exceed one full turn past hand tight when installing male threads into the check valve.

***WARNING:** Do not overtighten. Overtightening during installation will crack the valve body. Evidence of overtightening may not be readily visible or apparent upon pressurization. No user serviceable parts.
